High Risk Tree Overview 2019

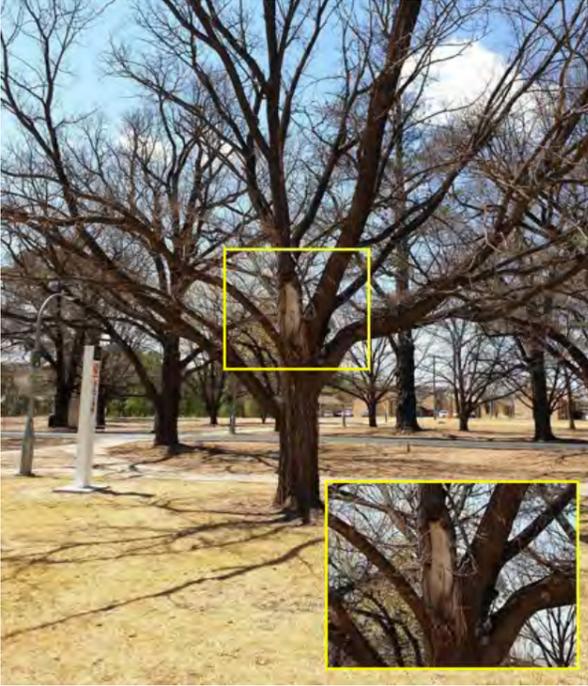
ID #	Name	Photo	Issue	Remedial Actions Considered	Action
178	Elm Tree (<i>Ulmus procera</i>)

<p>Stem failure at the included crown divergence point has resulted in unpredictable stability within the remaining crown structure.</p> <p>The tree has been left with poor crown structure, weak stem attachment points, limited life expectancy and poor ongoing aesthetic viability for a tree situated in such a prominent location.</p> <p>A pedestrian crossing, footpath and Meredith Road are all within the potential impact zone of further stem failures.</p>	<p>An exclusion zone is considered impractical on this occasion as the defective puts both the footpath path and Meredith Road within the potential fall zone.</p> <p>Reduction pruning of the two central stems to the level of the previous failure would result in a shortened life expectancy.</p>	<p>Removal and replacement with an advanced specimen. Replanting in situ within the Avenue is viable as there is adequate space and light.</p> <p>Replacement planting will be undertaken during winter, as this should offer the best chance of establishment for a deciduous species in this setting.</p>

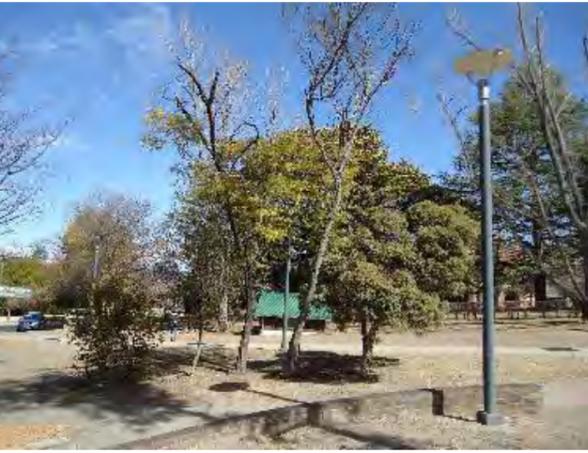
393	2 x Wattle (<i>Acacia floribunda</i>)

<p>Situated in a path side garden bed to the south of the library building. This is generally a short-lived species and these trees are dead.</p>	<p>No alternate recommendations were considered for these trees as they are small, dead specimens overhanging a busy pedestrian path.</p>	<p>Removal and replacement.</p>

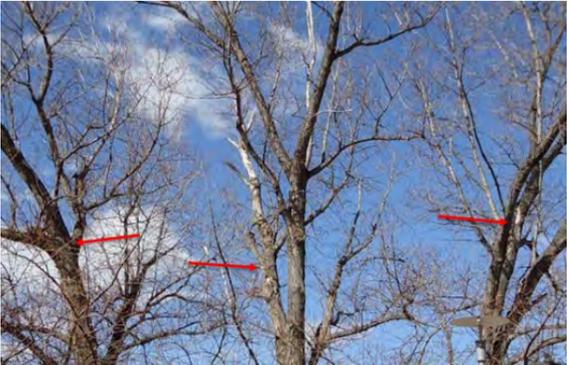
ID #	Name	Photo	Issue	Remedial Actions Considered	Action
395, 396 & 397	Poplar (<i>Populus yunnanensis</i>)

Compounding structural and health defects, previous large branch failures, limited life expectancy, in a prominent location.	Reduction pruning would result in shortened life expectancy.	Removal and replacement with advanced specimens of an alternative, longer lived species, to form an avenue along the side of the building
418	Flooded Gum (<i>Eucalyptus grandis</i>)

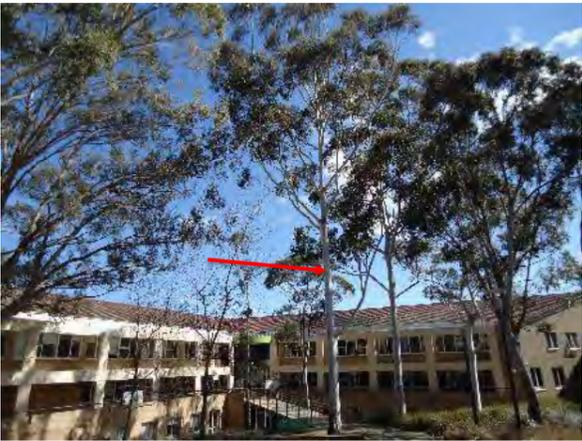
The tree was identified as presenting evidence of previous branch failures, excessive end weight, deadwood and wounds within various branch attachment points. An aerial assessment was undertaken in 2017 which recommended reducing the end weight of two branches within the crown structure, these being the lowest eastern and southern branches.	NA	Remove all deadwood and undertake end weight reduction pruning of targeted branches

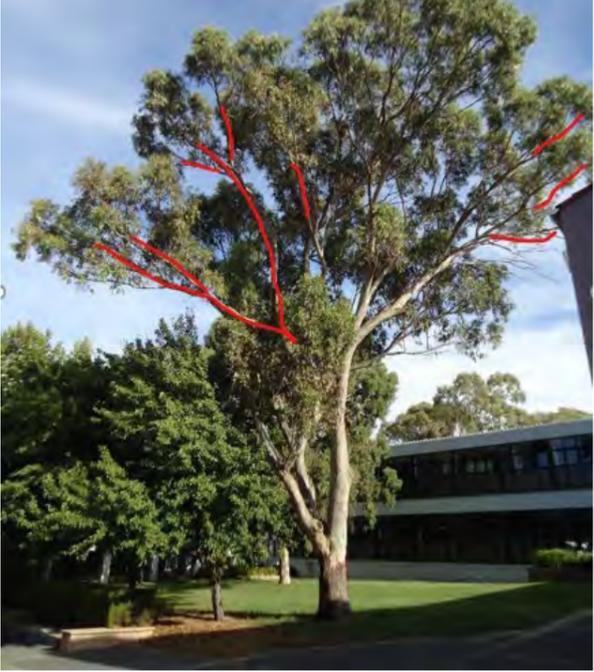
437	Blakely's Red Gum (<i>Eucalyptus blakelyi</i>)

The tree has experienced multiple previous branch failures and displays excessive end weight, wounds and weak unions within the existing crown structure.	NA	Undertake targeted reduction pruning of various elongated, exposed or end weighted branches overhanging the pedestrian walkways to minimise the consequence of any potential future failure.

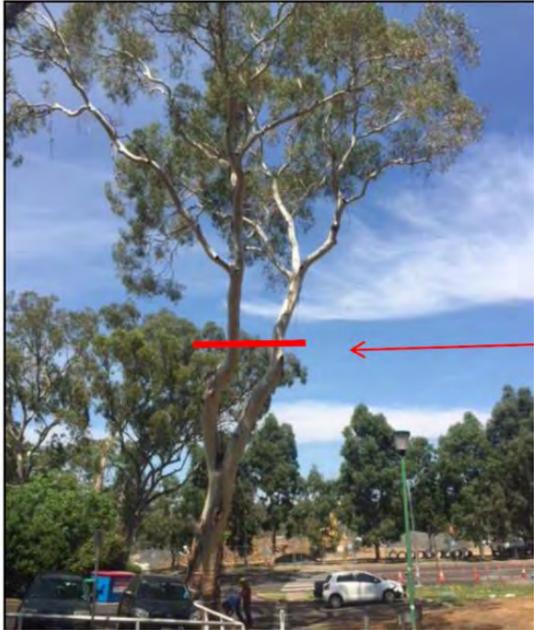
ID #	Name	Photo	Issue	Remedial Actions Considered	Action
518	Manna Gum (<i>Eucalyptus viminalis</i>)

<p>The tree presents with compounding structural defects, multiple cavities, internal decay, lean, history of branch failure.</p> <p>Aerial inspection and Resistograph testing were undertaken to ascertain the structural integrity of the tree and the condition of the significant structural issues identified.</p>	<p>Exclusion Zone – considered impractical in this situation due to the tree’s location, overhanging a busy pedestrian footpath and the size of the potential impact zone in the event of whole of tree failure; Removal – loss of habitat.</p>	<p>Habitat prune and retain for habitat for the short term. Undertake replacement planting around retention pond.</p>
754	Lombardy Poplar (<i>Populus nigra Italica</i>)

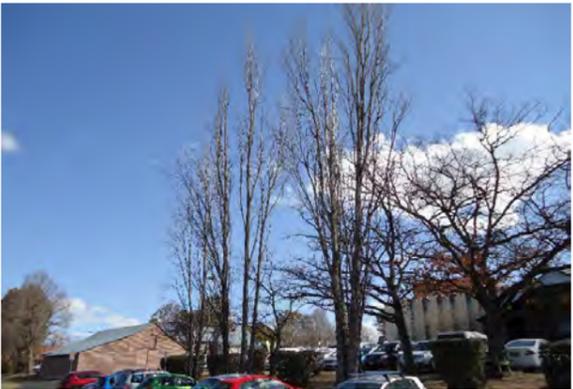
<p>The tree is in declining health with dead stems and poor structural stability due to advanced basal decay. An adjacent Lombardy Poplar, Tree 752 identified as High Risk in 2018, failed during a storm event in early 2019.</p>	<p>No alternative actions considered appropriate due to extent of defect, age, species and location.</p>	<p>Landscape Advisory Committee recommend removal.</p>

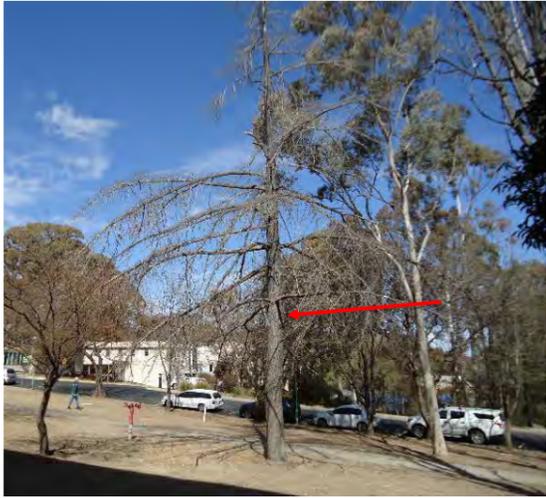
ID #	Name	Photo	Issue	Remedial Actions Considered	Action
867	Himalayan Cedar (<i>Cedrus deodara</i>)

Large dead tree which is starting to drop lateral branches. A concrete pedestrian pathway is within the impact zone.	No alternate recommendations were considered viable for this tree.	Landscape Advisory Committee recommend removal.
871	Lombardy Poplar (<i>Populus nigra Italica</i>)

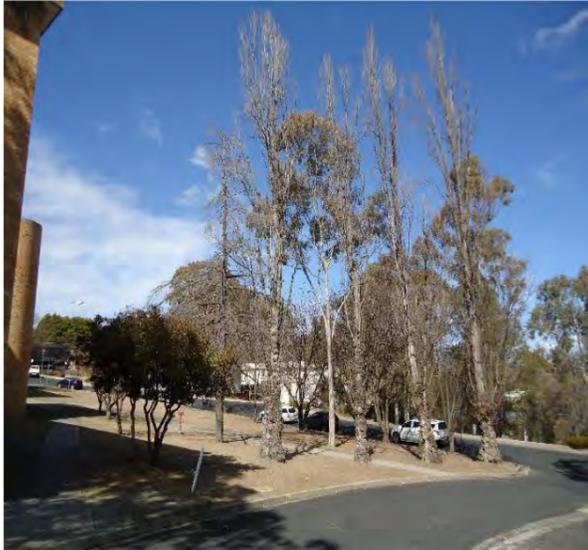
Large mature tree has significant basal decay making ongoing stability unpredictable. The decay was identified using a mallet and acoustically testing the base of the tree. Large branch dieback within the upper canopy is also an indicator of increasing dysfunction and health decline. No alternate recommendations have been made for this tree.	No alternative actions were recommended for this tree due to age, species and location.	Landscape Advisory Committee recommend removal.

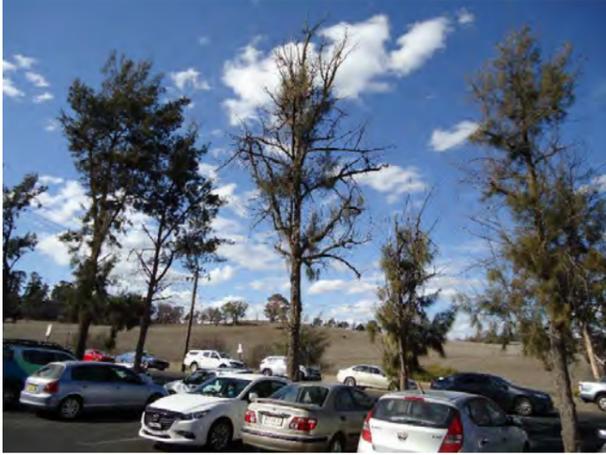
ID #	Name	Photo	Issue	Remedial Actions Considered	Action
1460	River She-Oak (<i>Casuarina cunninghamiana</i>)

<p>The semi-mature tree has declining health and is currently at the stage of shedding medium sized branches onto the road and carpark. Various other trees of the same species within similar locations were observed to be in declining health and will require removal over the coming years. The overall decline is attributed to a harsh growing conditions and limited root space.</p>	<p>No alternate recommendations were considered viable for this tree.</p>	<p>Landscape Advisory Committee recommend removal.</p>
2894	Narrow-leaved Peppermint Gum (<i>Eucalyptus nicholii</i>)

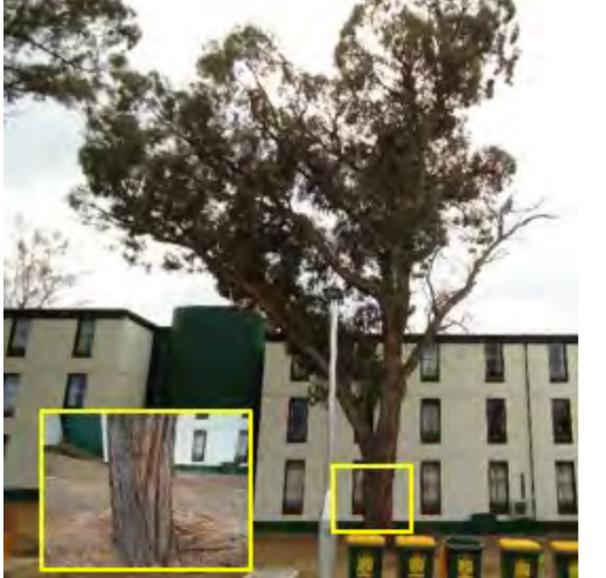
<p>Resistograph testing identified extensive internal basal decay making ongoing stability unpredictable</p>	<p>Exclusion zone - considered impractical due to size and location of the adjacent road and entry to Earl Page College; Habitat pruning was considered impractical due to defect location, species, location and aesthetics.</p>	<p>Assess for habitat, prune for and retain</p>

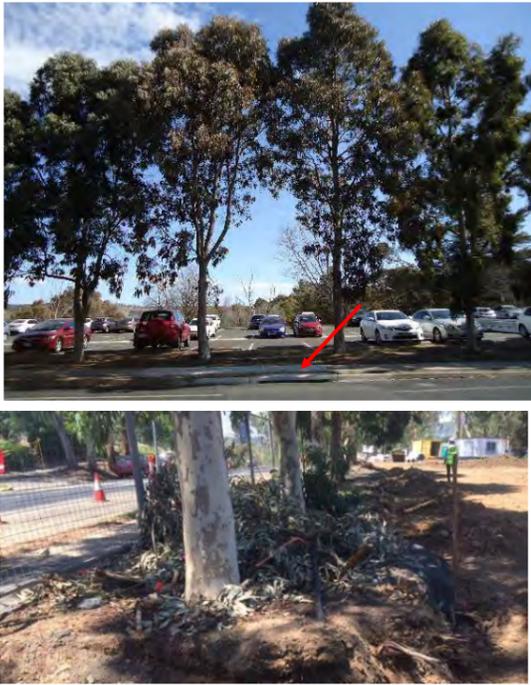
ID #	Name	Photo	Issue	Remedial Actions Considered	Action
4994 & 4995	Hillgrove Spotted Gums (<i>Eucalyptus michaeliana</i>)

<p>The trees sustained significant structural damage to the west and south during the 2018 carpark and stormwater upgrade making long-term stability unpredictable (refer to report with FMS). Trevenna Road, the roadside footpath and the carpark are within the potential impact zone. Tree stability is still regarded as unpredictable although no health or structural deterioration has been observed since the initial damage was sustained</p>	<p>No alternate recommendations have been made for these trees due to severity of root damage on two sides of the root plate and relative ease of replacement due to age.</p>	<p>Removal and replacement with species to be guided by the Landscape Advisory Group.</p>
161	Narrow-leaved Peppermint Gum (<i>Eucalyptus nicholii</i>)

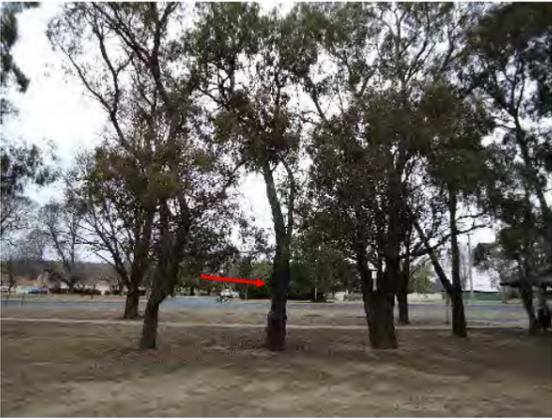
<p>Deteriorating and decayed lower trunk wound resulting in unpredictable stability. The tree overhangs the Elm Avenue pathway and entry to a bus pick up point and shelter.</p> <p>The tree is part of a larger, grouped planting of same species trees situated in the immediate vicinity.</p>	<p>No alternate recommendations were considered for this individual tree due to the species, location and severity of defect.</p>	<p>Removal and replacement with species to be guided by the Landscape Advisory Group.</p>

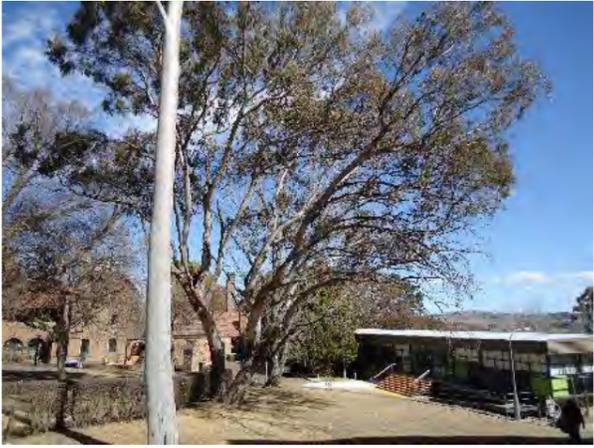
ID #	Name	Photo	Issue	Remedial Actions Considered	Action
361	Manna Gum (<i>Eucalyptus viminalis</i>)

Overhanging managed grass and pathways. A build-up of larger diameter deadwood was observed within the canopy	NA	Remove deadwood.
431	English Oak (<i>Quercus robur</i>)

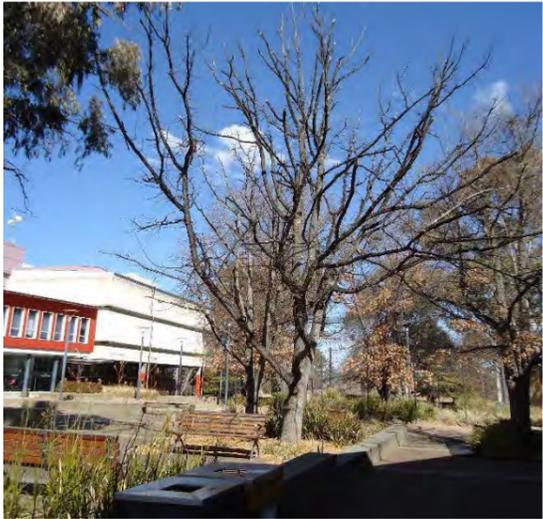
The tree has been declining in health for a number of years, with the decline attributed to harsh growing conditions and limited root space. Tree health and structure are poor with the canopy consisting of decayed, dead and dying branches and small epicormic growth.	Student seating and paved areas are within the potential impact zone of failing branches. On Graduation Day on August 30 a branch fell from the tree and became wedged between two other branches. The fallen branch was removed for the safety of students, staff and visitors to the ceremony.	Removal and replacement.
882	Manna Gum (<i>Eucalyptus viminalis</i>)

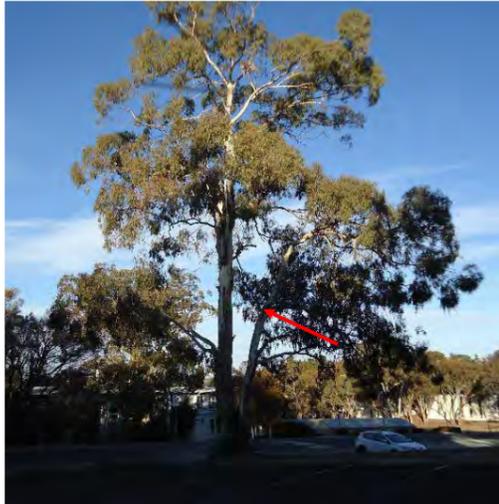
<p>Overhanging a managed grass area and carparking spaces. The tree presented with a degraded included basal union between the main stem and a smaller northern stem with multiple branch failure points and larger wounds within the canopy.</p> <p>An aerial inspection found four significant defects.</p> <p>Multiple small to medium sized branch failure points were observed throughout the canopy. These branch failures were attributed to the trees age, size, exposed position to prevailing western storm winds and an end weighted Eucalypt branching structure.</p>	No alternate recommendations were considered for this tree due to its age, severity of defect and location.	Prune and deadwood.

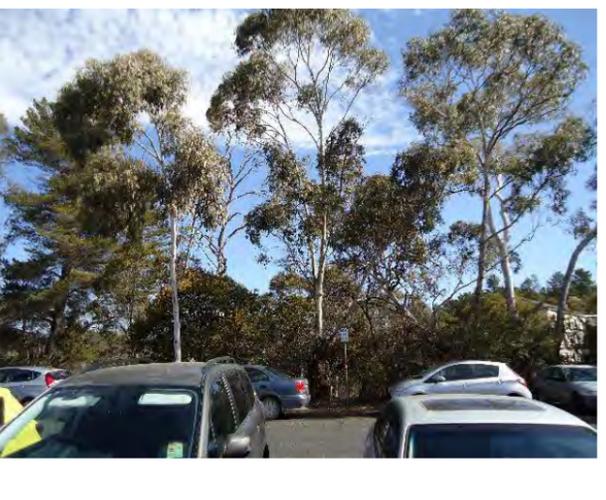
ID #	Name	Photo	Issue	Remedial Actions Considered	Action
1060	Manna Gum (<i>Eucalyptus viminalis</i>)

The tree has an included union at 5m between its two main stems. The union is starting to separate and considered structurally weak. The busy Mary White College southern carpark is within the potential impact zone of stem failure.	No alternate recommendations were considered for this tree due to its age, severity of defect and location.	Landscape Advisory Committee recommend removal.
1062	Manna Gum (<i>Eucalyptus viminalis</i>)

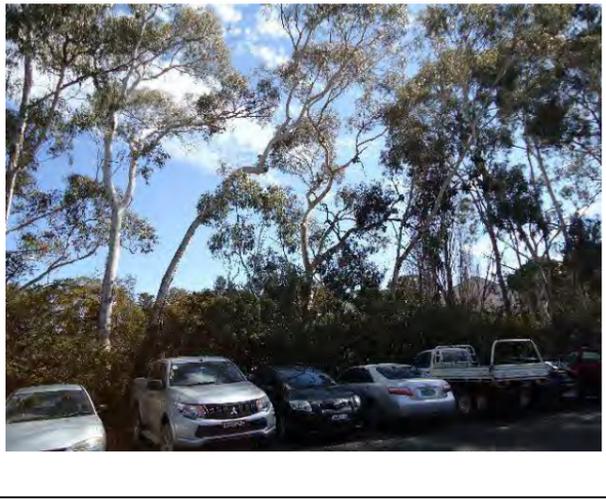
The tree presents with a deteriorating wound on the tension side of the lower stem. Significant decay, with associated fungal fruiting bodies, makes on-going stability unpredictable.	No alternate recommendations were considered for this tree due to its age, severity of defect and location.	Landscape Advisory Committee recommend removal.
1365	Bhutan cypress (<i>Cupressus torulosa</i>)

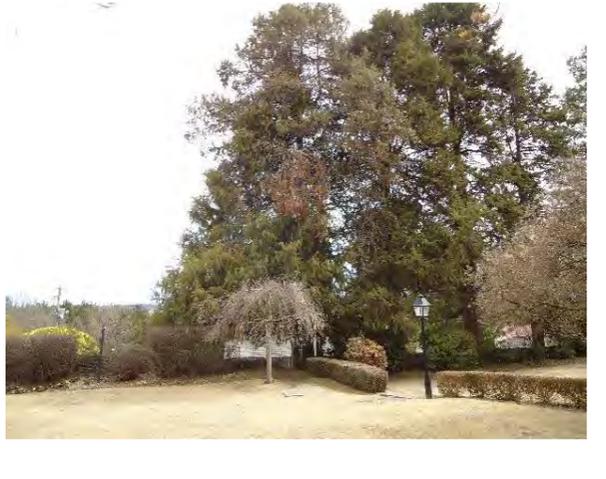
A mid canopy branch, previously recommended for preventative reduction pruning in earlier assessments, has failed and is now hung up in the canopy.	NA	Remove the failed branch back to an appropriate branch union

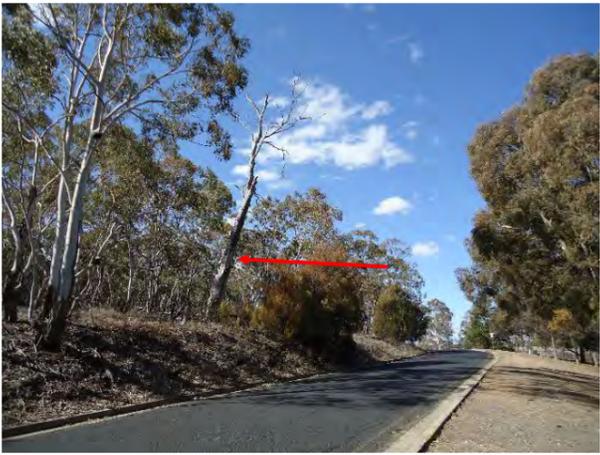
ID #	Name	Photo	Issue	Remedial Actions Considered	Action
1821	Gum tree (<i>Eucalyptus</i> sp.)

Tree has deteriorated to the point where whole of tree failure is considered likely due to a degrading lower trunk cavity and decay. The ring road is within the potential impact zone of the top of the tree.	NA	Reduce height to negate collapse on to Ring Rd and retain for habitat
2521	Poplar trees (<i>Populus</i> sp.)

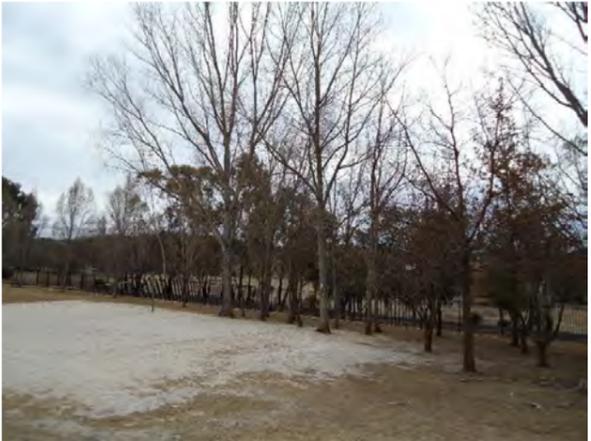
Dead semi-mature poplar trees	NA	Landscape Advisory Group suggest remove all poplars over hanging Volleyball court
2598	Mexican Weeping Pine (<i>Pinus patula</i>)

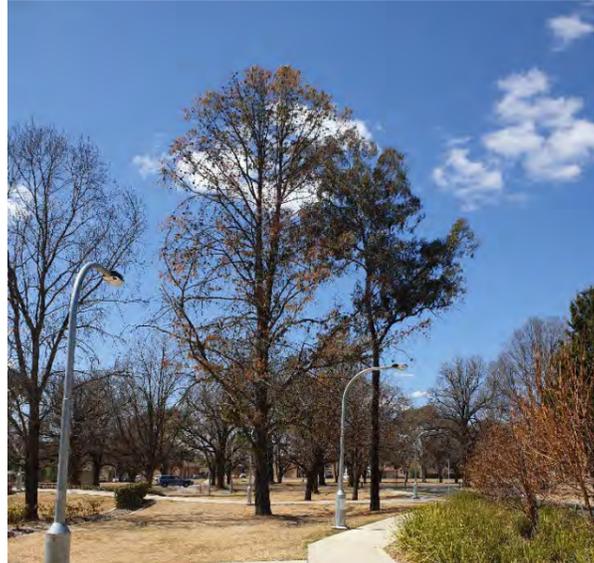
Tree is declining in health as attributed to drought and previous root damage during the building's construction with a subsequent build-up of large dead wood. A student entrance pathway is within the potential impact zone.	NA	Landscape Advisory Group recommend removal.

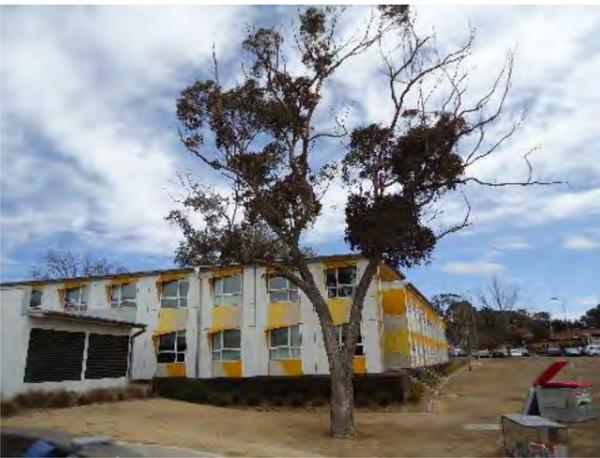
ID #	Name	Photo	Issue	Remedial Actions Considered	Action
2636	Yellow Box (<i>Eucalyptus melliodora</i>)

Tree is in a reduced state of health with reduced canopy density, large terminal branch dieback & the remaining foliage mass consisting of 100% epicormic growth. The decline is attributed to suspected root damage during the construction of Wright College.	Remove deadwood and retain for the short term are both considered valid options.	Landscape Advisory Group recommend removal and replacement
2719	Yellow Box (<i>Eucalyptus melliodora</i>)

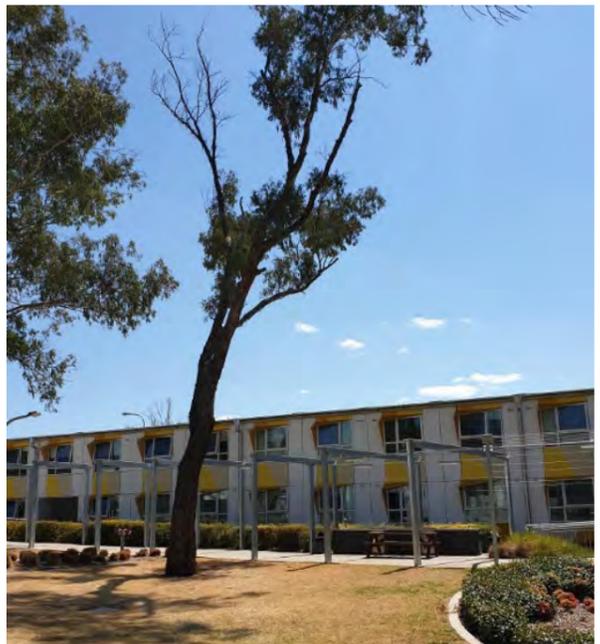
Tree has been declining in health for a number of years, with the decline attributed to suspected root damage sustained during the construction of Wright College. Drought conditions and previous basal decay are compounding factors in the decline. Deadwood pruning has previously been undertaken.	No alternate recommendations were considered for this tree due to the location, large size, previous pruning works and ongoing health deterioration.	Remove and replace or remove deadwood and retain for short term.

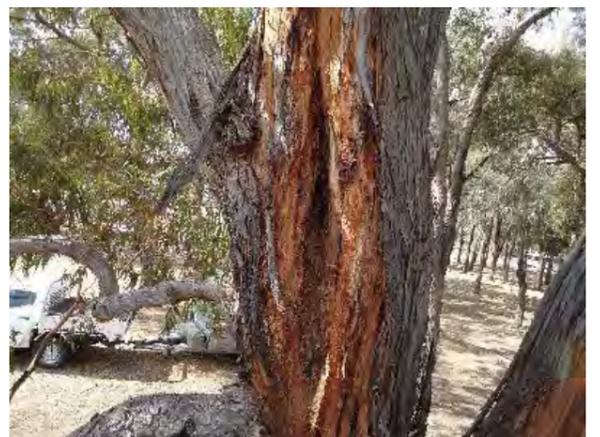
3046	Narrow-leaved Peppermint Gum (<i>Eucalyptus nicholii</i>)

An aerial inspection was undertaken to validate the severity of defects identified during the ground assessment. Four defects were considered severe.	NA	Landscape Advisory Group recommend removal.

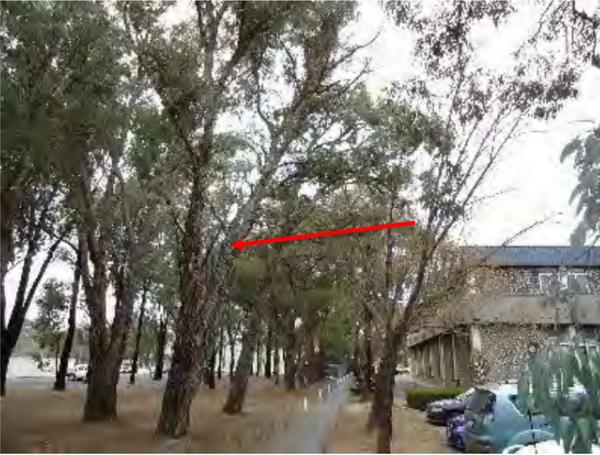
ID #	Name	Photo	Issue	Remedial Actions Considered	Action
3243	Narrow-leaved Peppermint Gum <i>(Eucalyptus nicholii)</i>

A large dead central stem shows increasing instability and deterioration.	Remove dead stem overhanging the carpark back to the trunk union at 2m.	Landscape Advisory Group recommend removal.
10	Dead tree <i>(Eucalyptus sp.)</i>

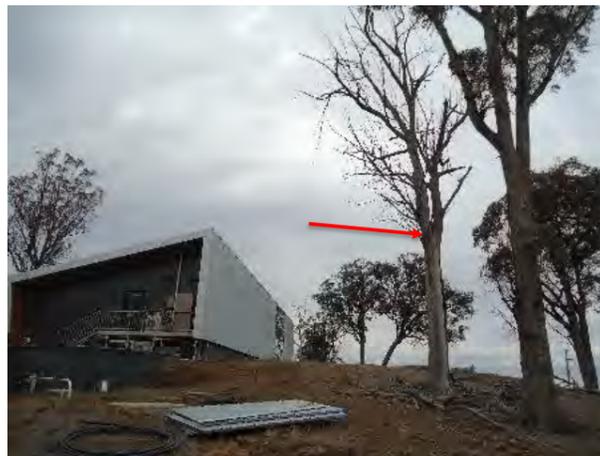
Tree is slowly disintegrating with both the building and a water tank within the potential impact zone of larger branch/stem failures. Anecdotal evidence suggests that the area under the tree is used as a student pathway between the building and the main test paddocks located to the south.	Exclusion Zone considered impractical in this situation due to the tree's location overhanging a pedestrian desire line and the potential for impact onto infrastructure	Habitat pruning.
123	English Elm <i>(Ulmus procera)</i>

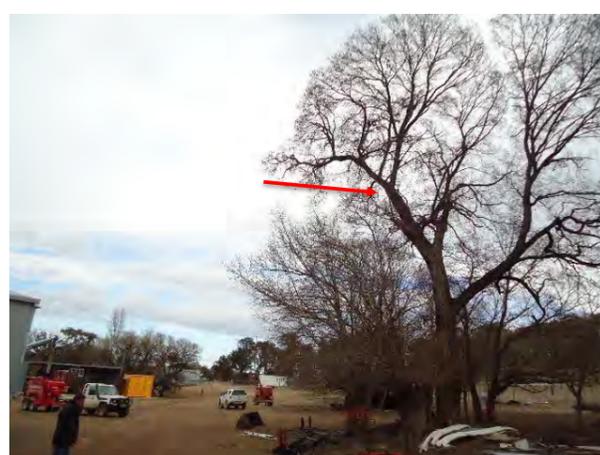
Tree presents with multiple compounding defects (decay, previous failures, cavities, cracks, sap exudation, active fungal pathogens, wounds, asymmetric crown structure) within the lower trunk area. The compounding effects of the defects have added pressure to the basal area resulting in partial failure, as indicated by weeping cracks on both sides of the trunk, which make for unpredictable ongoing stability and limited ULE. The tree displays evidence of multiple large branch failures also indicating a history of canopy failure.	Exclusion Zone considered impractical in this situation due to the tree's defects, size and location - overhanging the adjacent forecourt	Remove.
