# UNE

# Asbestos Management Plan

## 2024

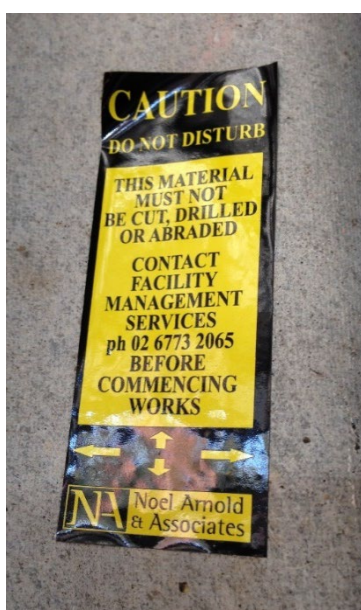
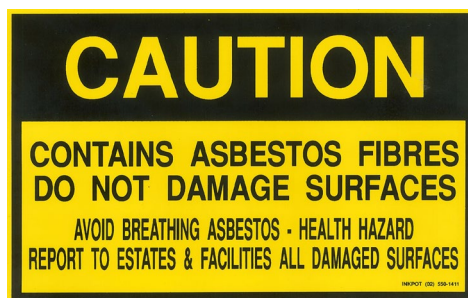
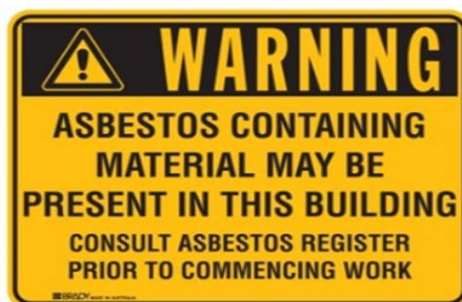
*Examples of signage and labelling are below*

- there is difficulty accessing areas, signage has been installed adjacent the access points, including entries to ceiling cavities and subfloor spaces, and
- the placement of labels creates other safety hazards.

In the event confirmatory testing identifies asbestos /ACM in new locations, UNE will add these to the Asbestos Register and if reasonably practicable, affix a label.

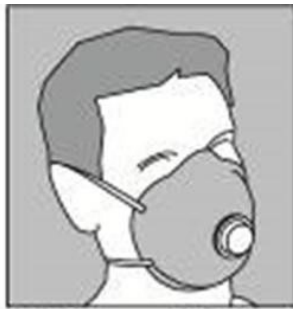
**Figure 1** Disposable, half-face particulate respirator

The recommended respirators for use in dealing with the asbestos items is indicated in Figures 1 & 2 below. The respirators indicated have the same protection factor for dealing with asbestos.

The asbestos kit should contain 1-2 boxes of disposable, half-face P2 particulate respirators.
